Seeking Input on Border Barrier Remediation in Tucson, AZ

CBP welcomes input on proposed border barrier construction remediation actions in Pima, Santa Cruz, and Cochise Counties, AZ

January 2022

This StoryMap depicts the conditions of the border barrier projects as of July 2021 and proposed remediation strategies.

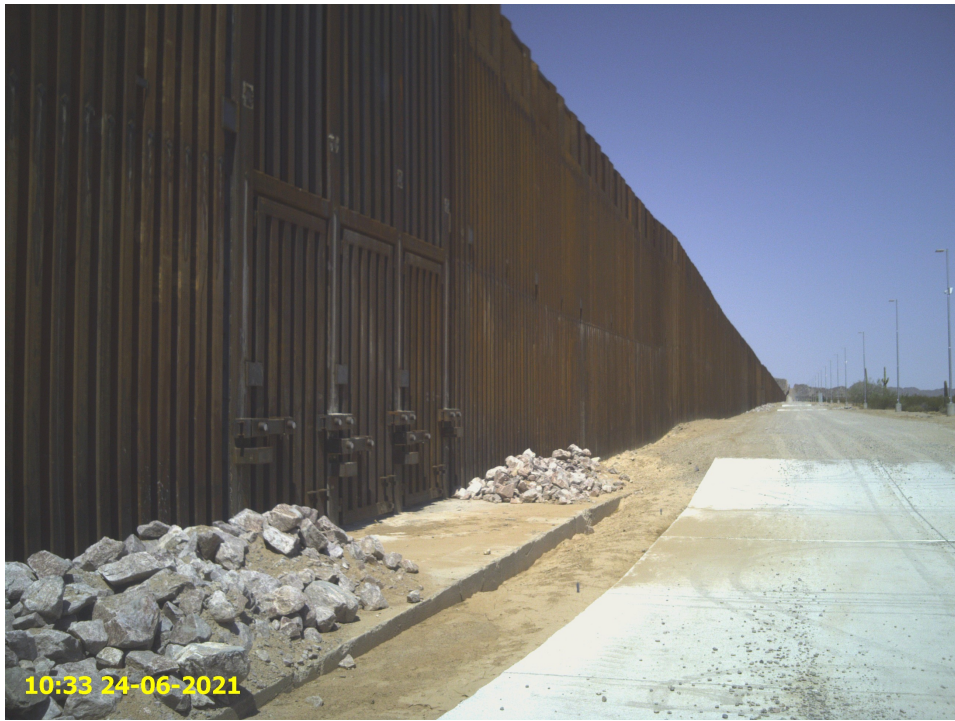
Protect low water crossings with appropriate drainage measures

- All drainage crossings will be protected by appropriate measures such as, but not limited to, articulated concrete block, concrete pavement, inlets/outlets, culverts, roadside ditches, debris posts, or a combination thereof.

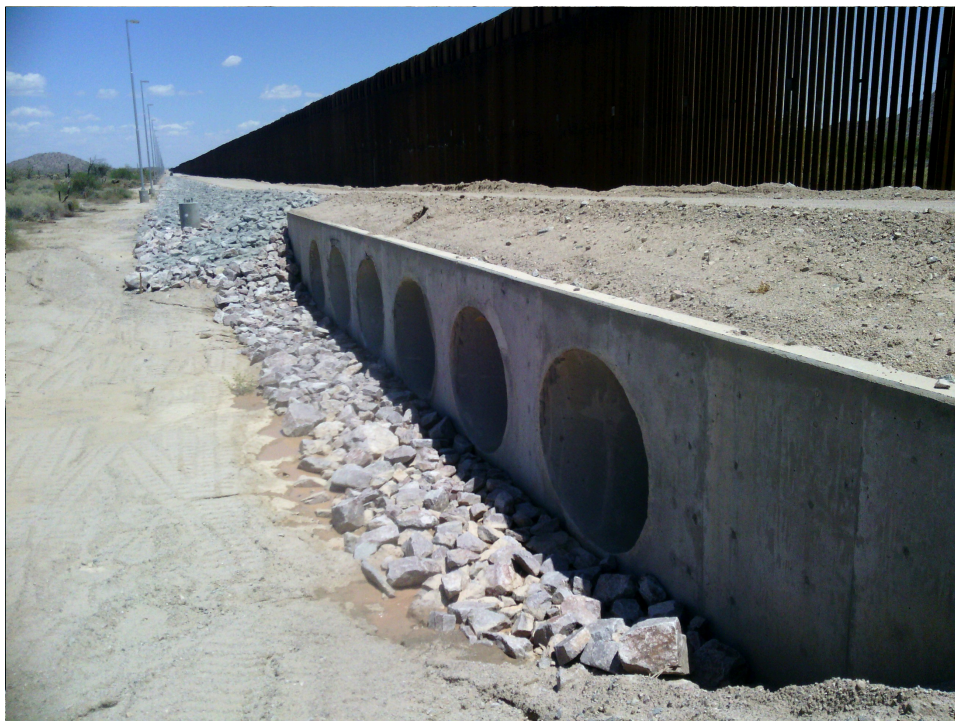
Protect culverts with appropriate drainage measures

- All drainage crossings will be protected by appropriate measures such as, but not limited to, articulated concrete block, concrete pavement, inlets/outlets, culverts, roadside ditches, debris posts, or a combination thereof.

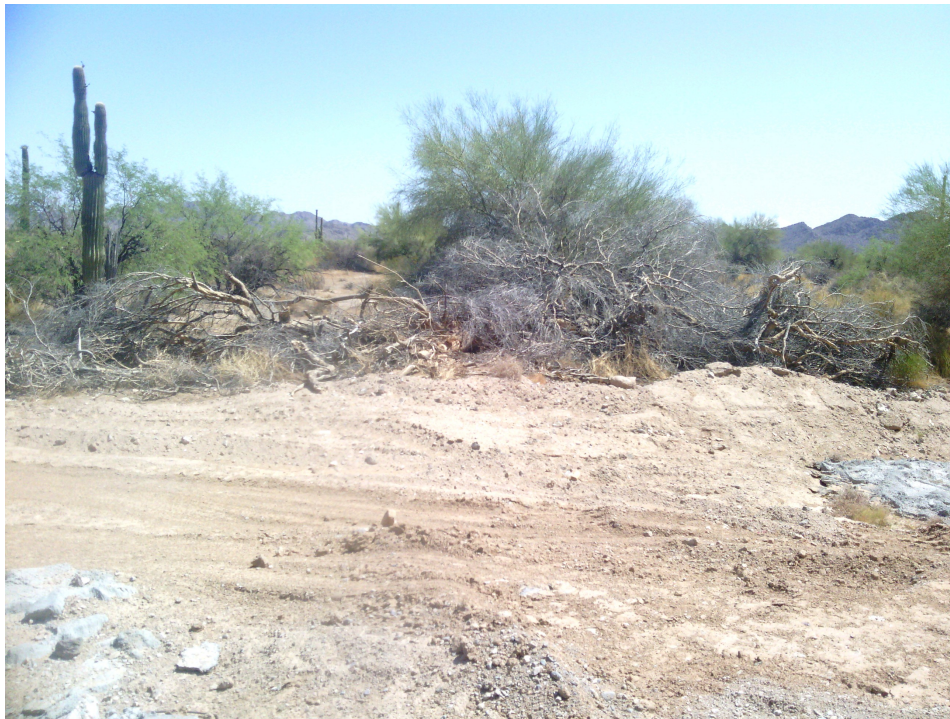
Remove vegetation debris north of the Roosevelt Reservation and reseed disturbed land

- Areas outside the 60-foot Roosevelt Reservation and established patrol road will be reseeded in accordance with specifications provided by Federal land managers.

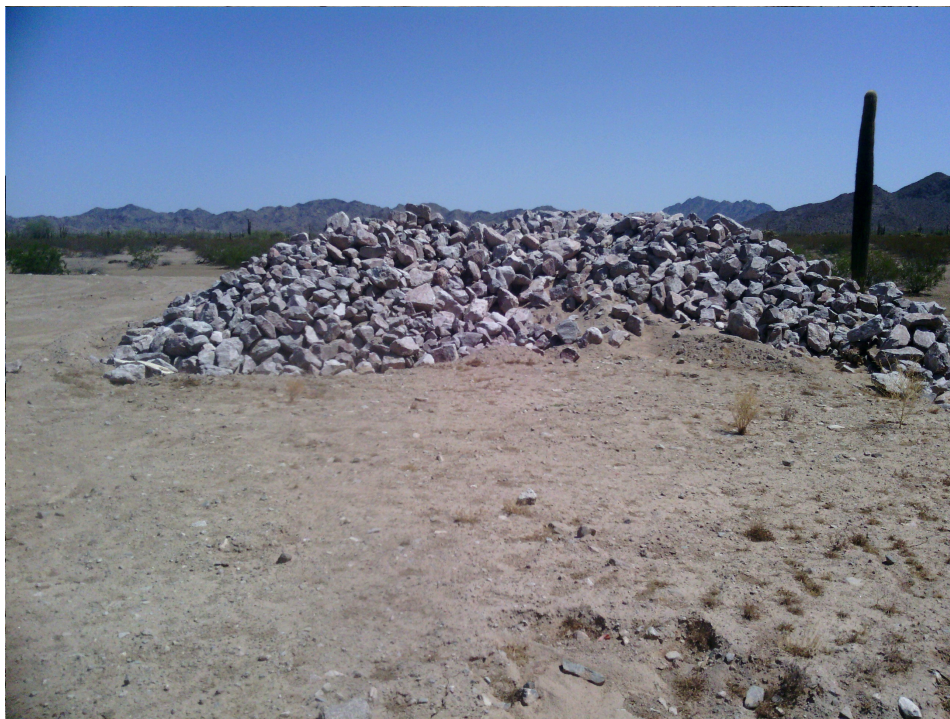
Remove construction materials and reseed staging areas outside of the Roosevelt Reservation

- Areas outside the Roosevelt Reservation will be reseeded in accordance with specifications provided by Federal land managers.

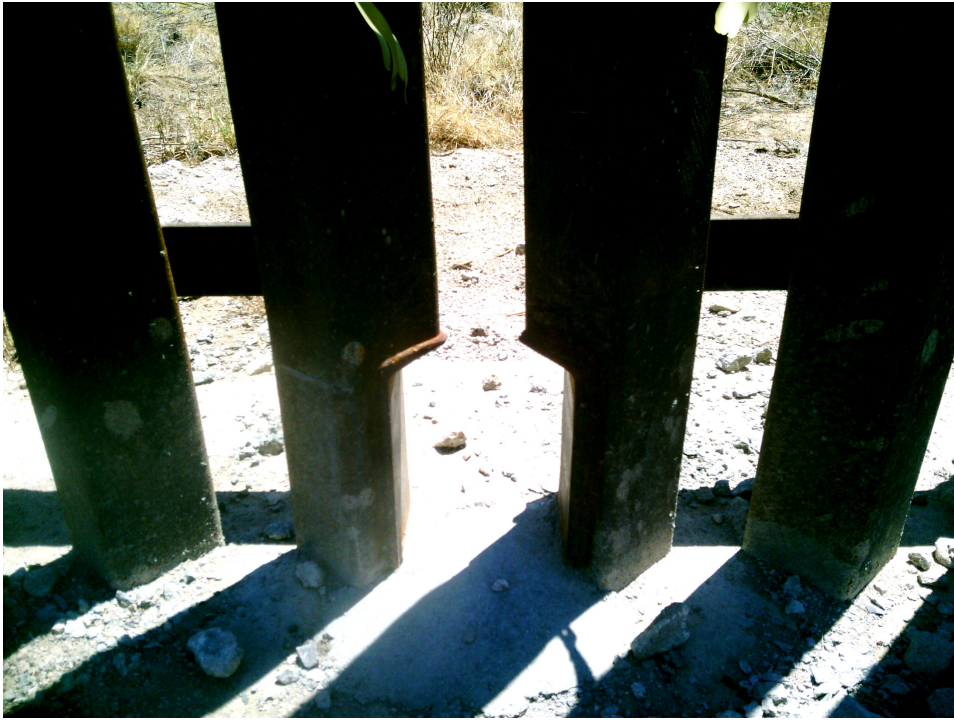
Install and maintain small wildlife openings

- Additional small wildlife passages will be installed in previously identified areas.

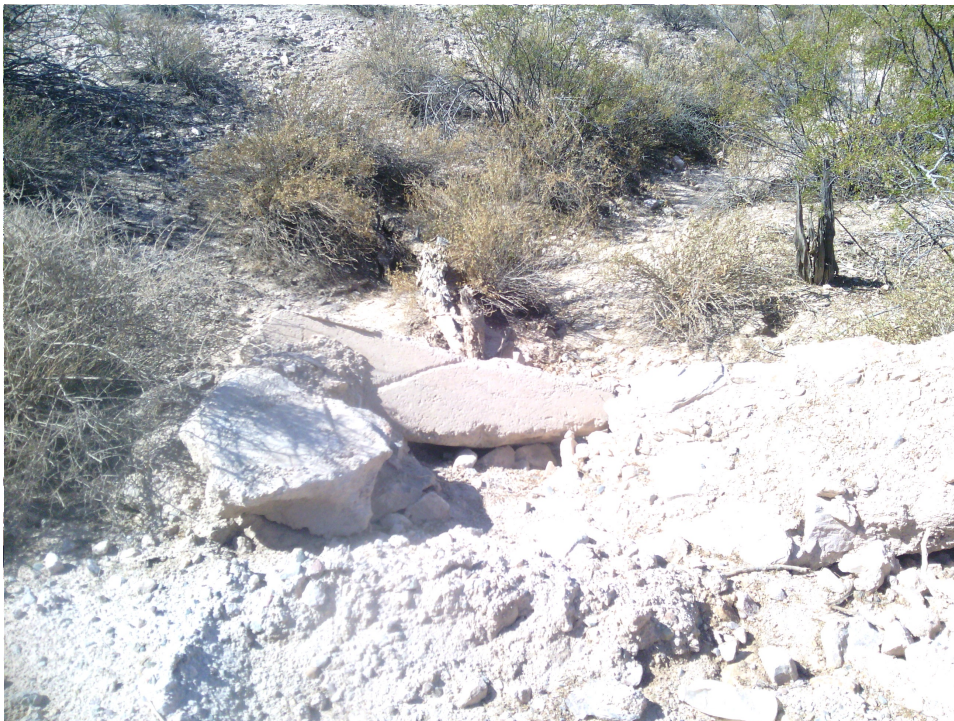
Protect culverts with appropriate drainage measures

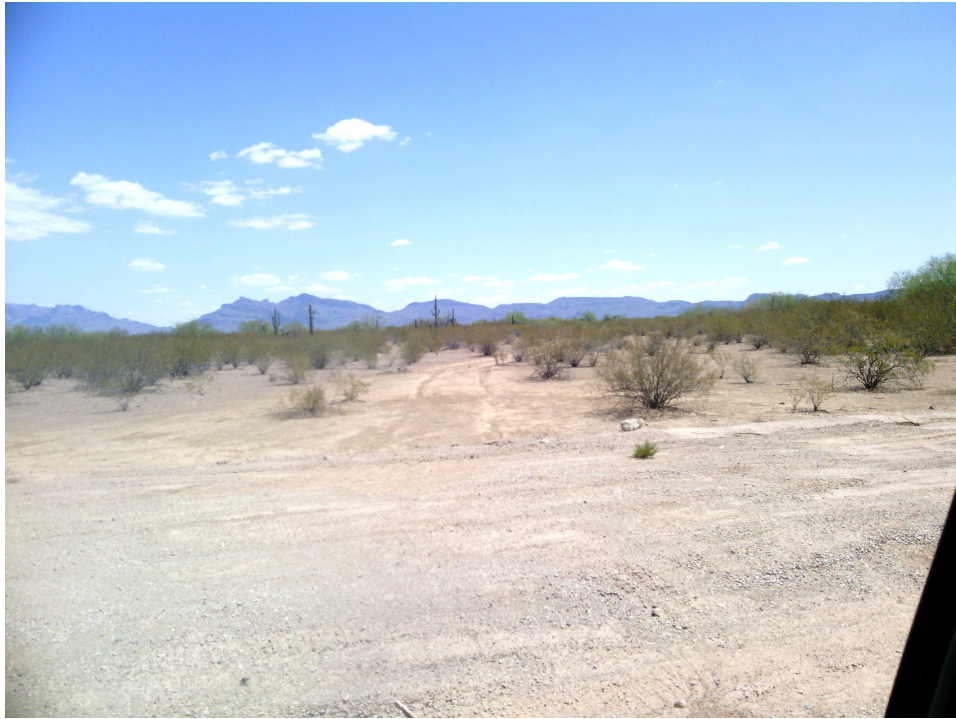
Restore, retain, or decommission roads used in construction

- CBP will work with USBP and other relevant agencies to determine which construction roads will be retained and which will be decommissioned. Some roads will be repaired and/or restored in accordance with previously established agreements with Federal land managers.

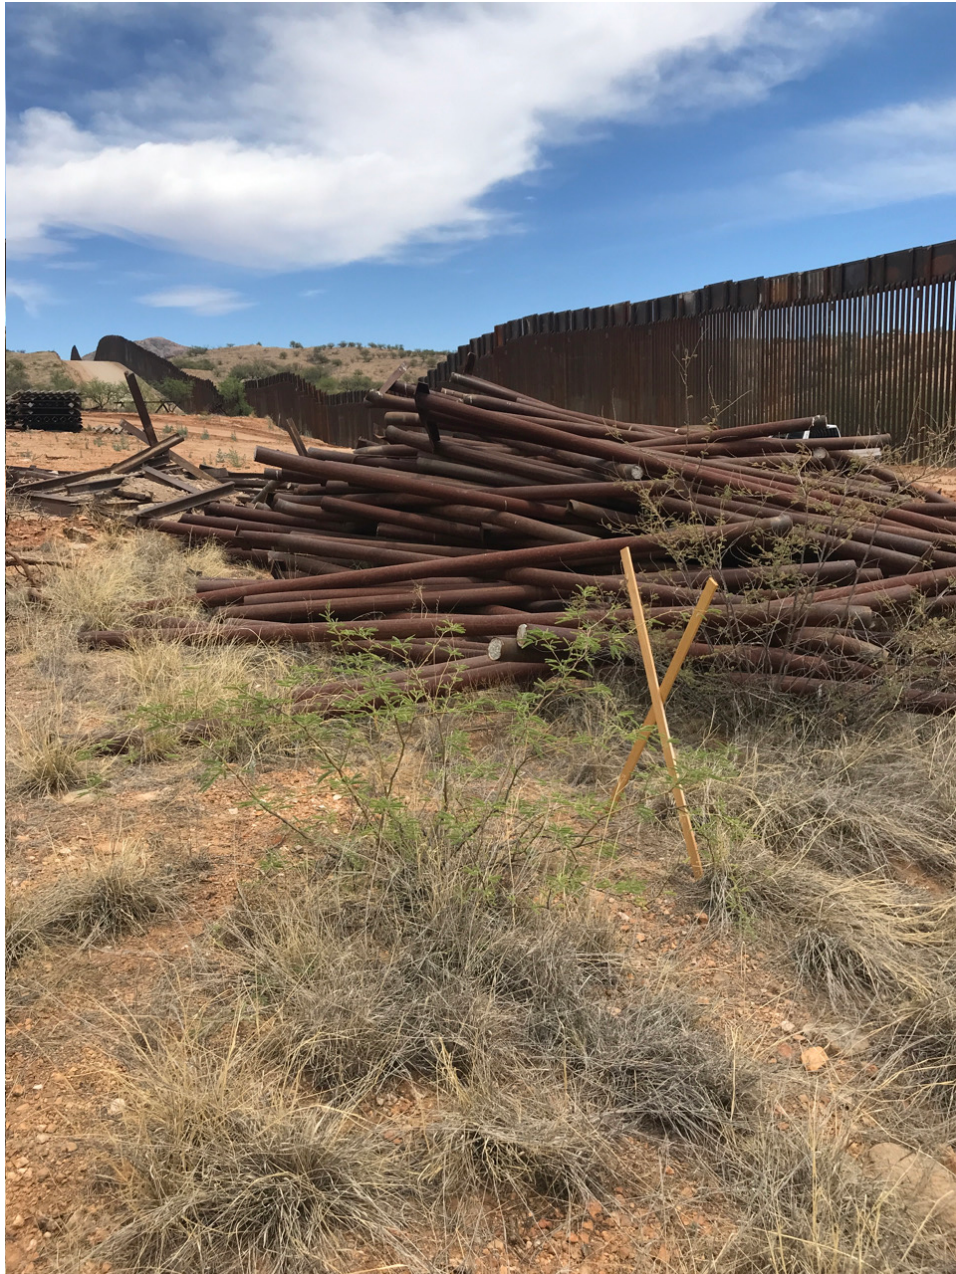
Reseed staging areas outside of the Roosevelt Reservation

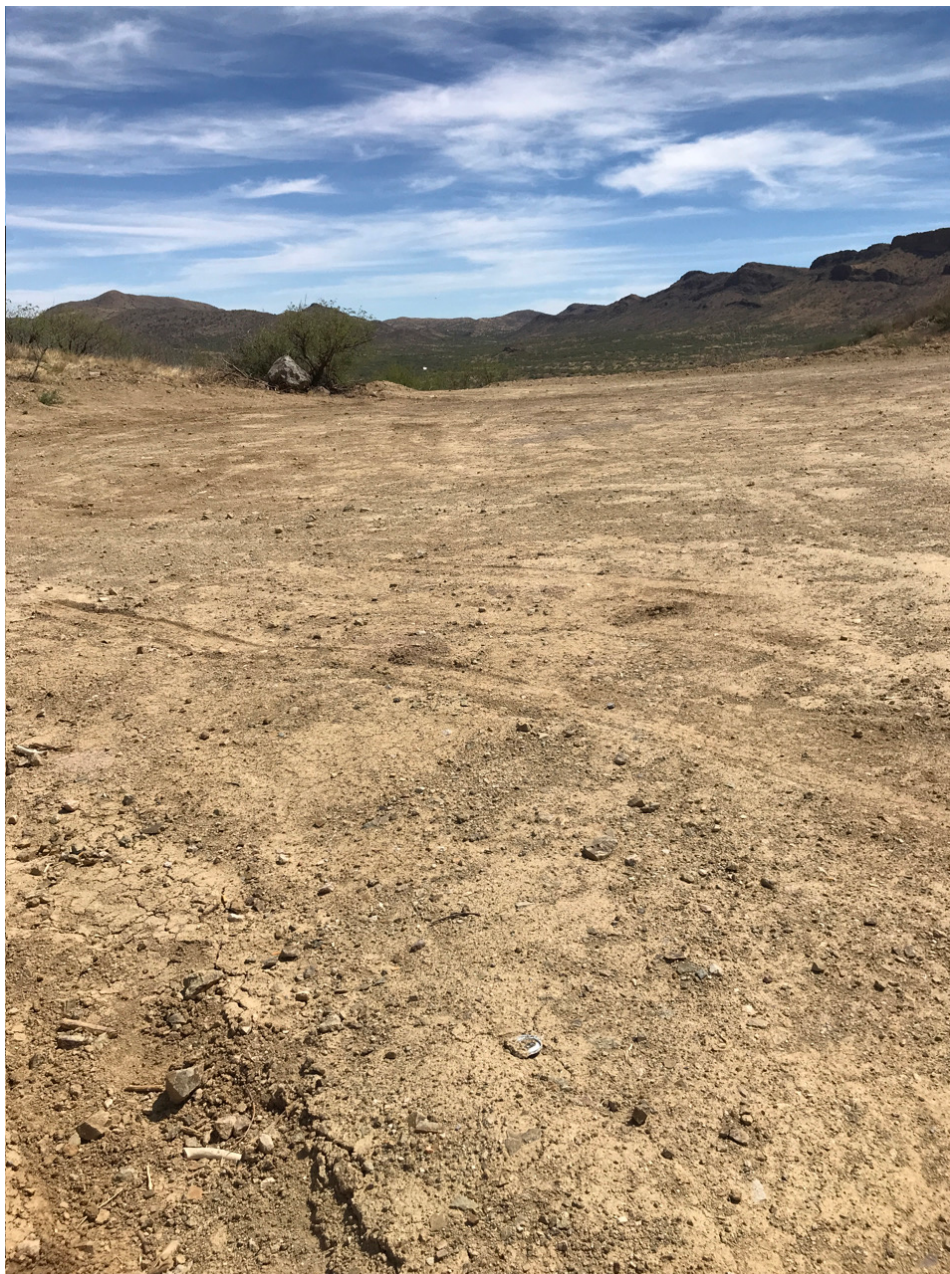
Reseed staging areas outside of the Roosevelt Reservation

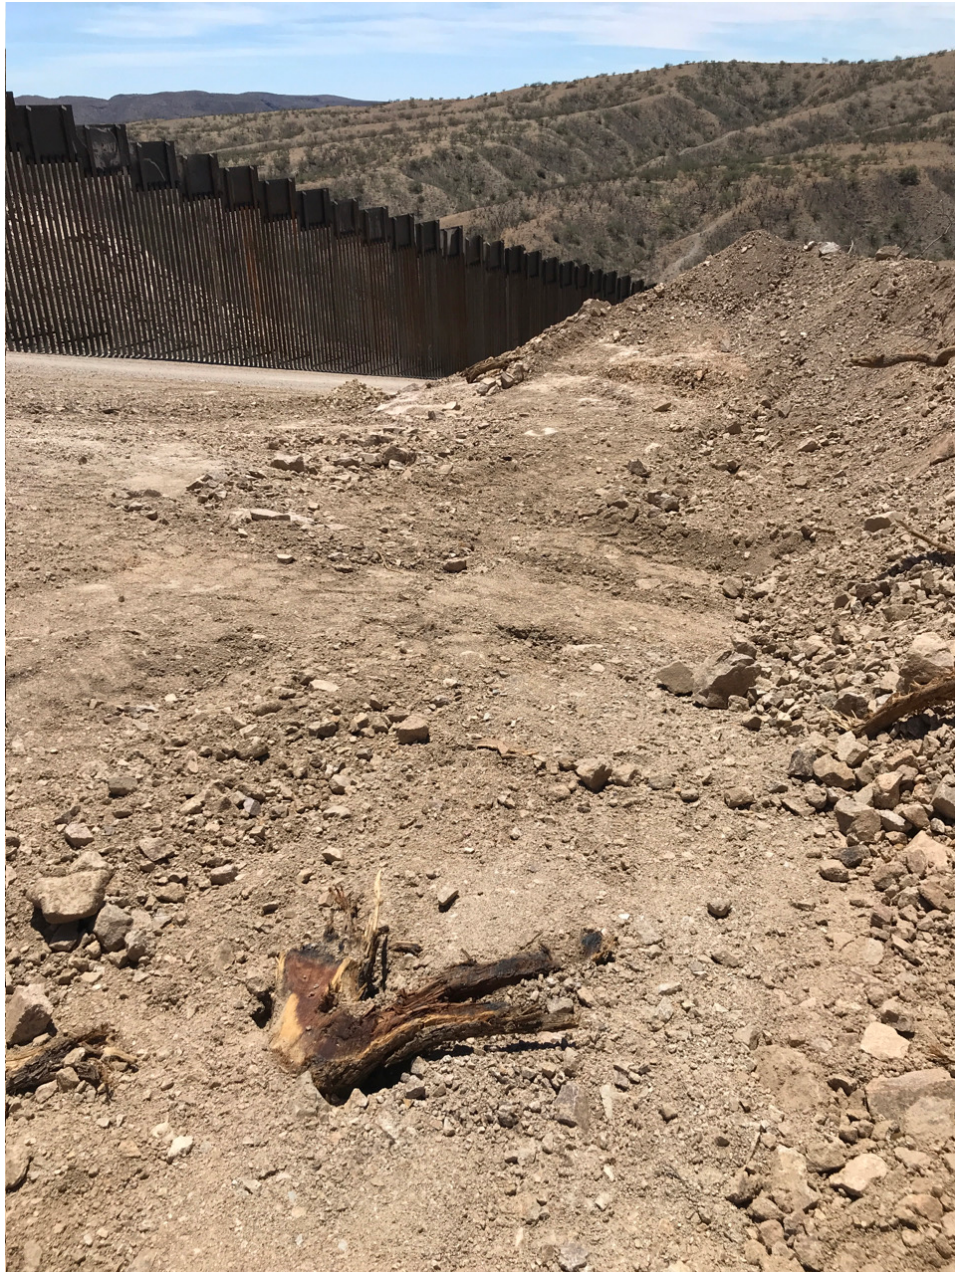
Disturbed areas outside the Roosevelt Reservation will be reseeded in accordance with specifications provided by Federal land managers

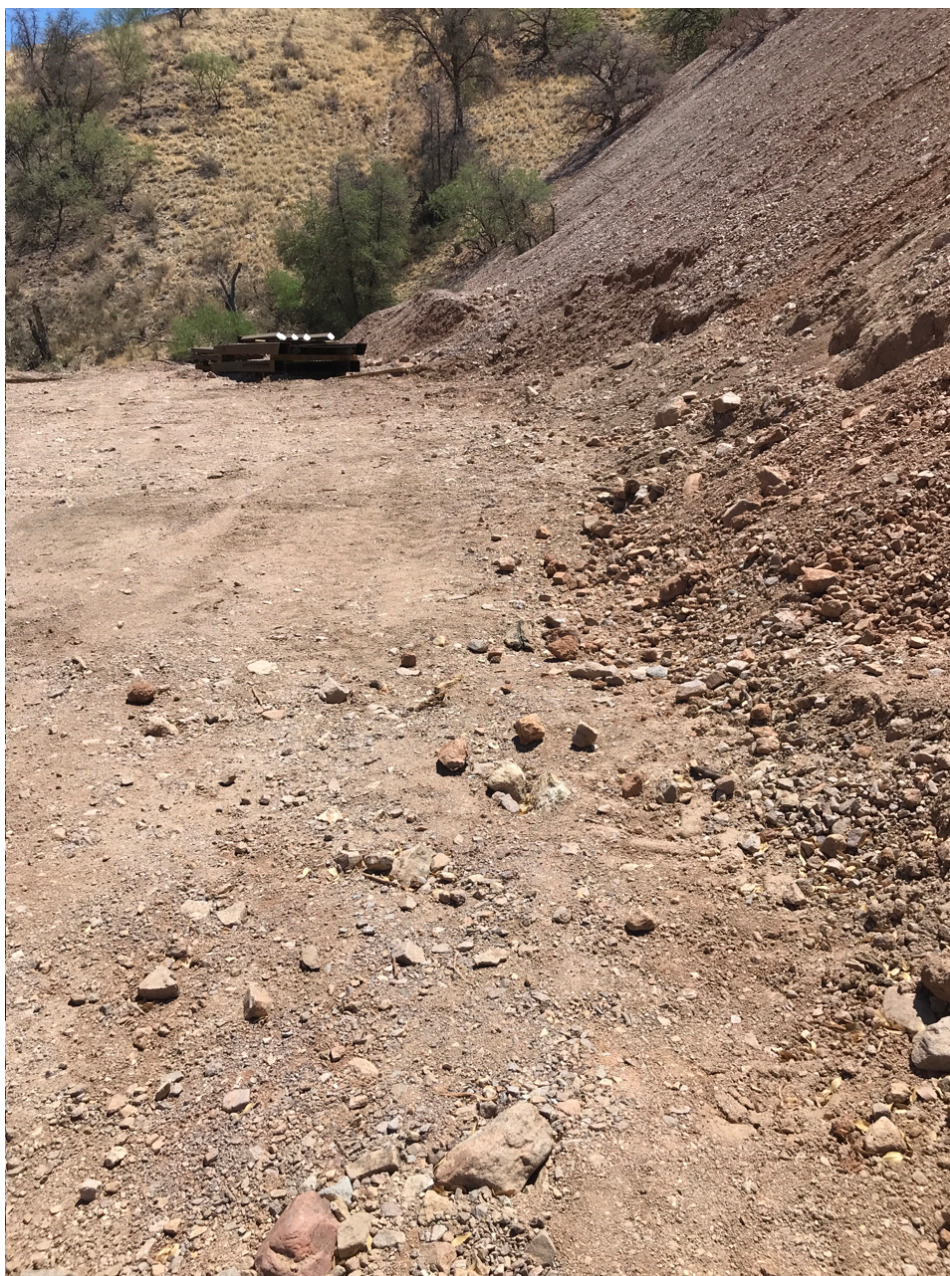
Installation of embankment/slope stabilization along slopes and drainages

- Short-term and long-term erosion control measures will include installation of rip rap and other embankment/slope stabilization along slopes and drainages.

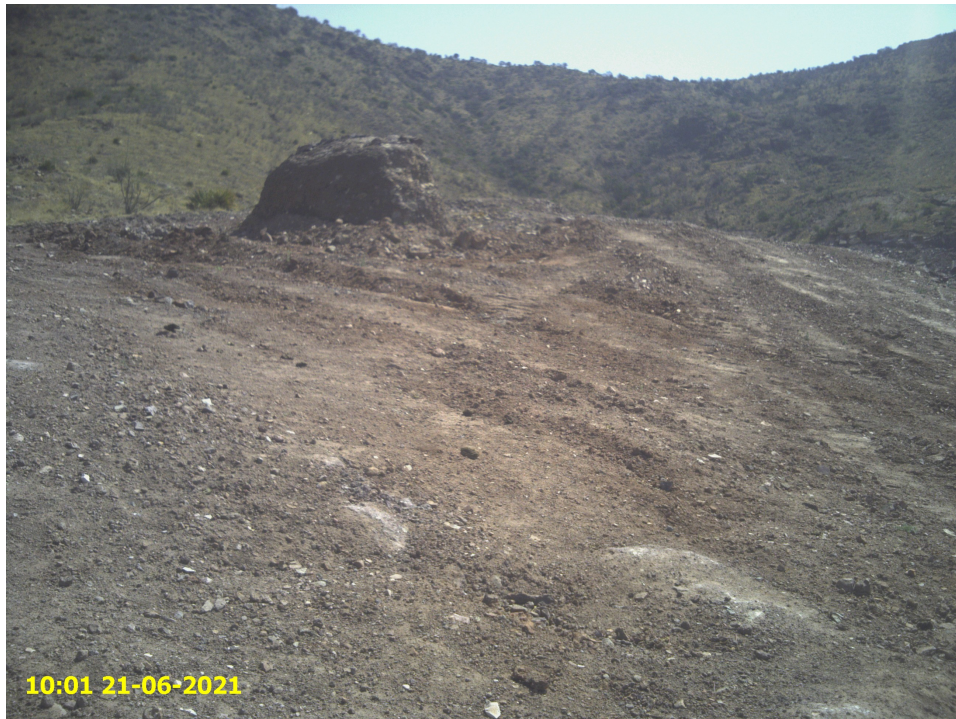
Reseed staging areas outside of the Roosevelt Reservation

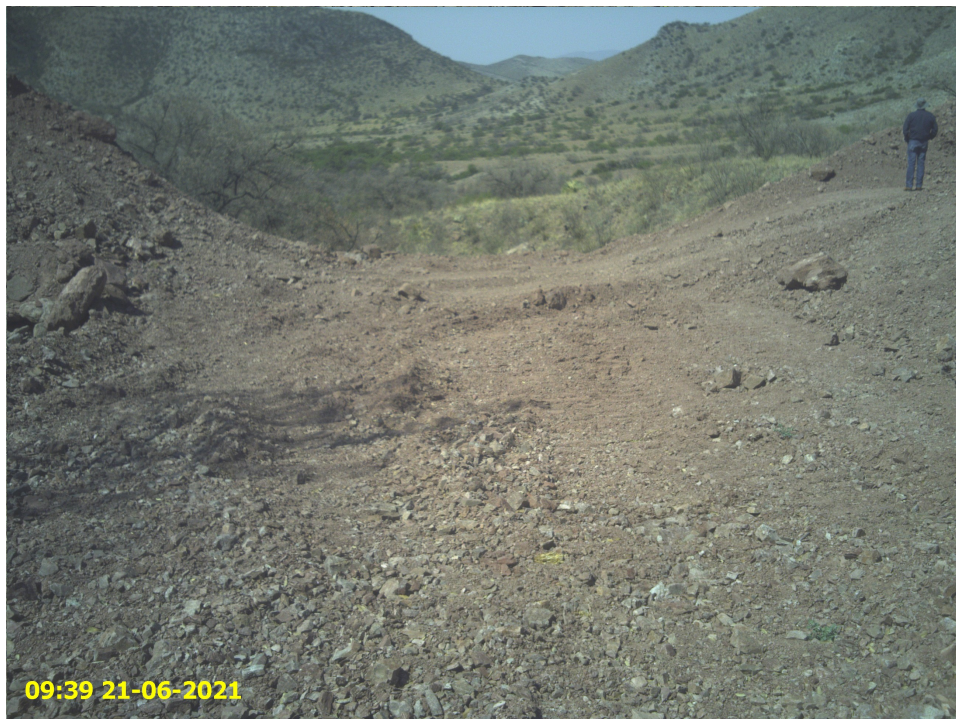
Protect low water crossings with appropriate drainage measures

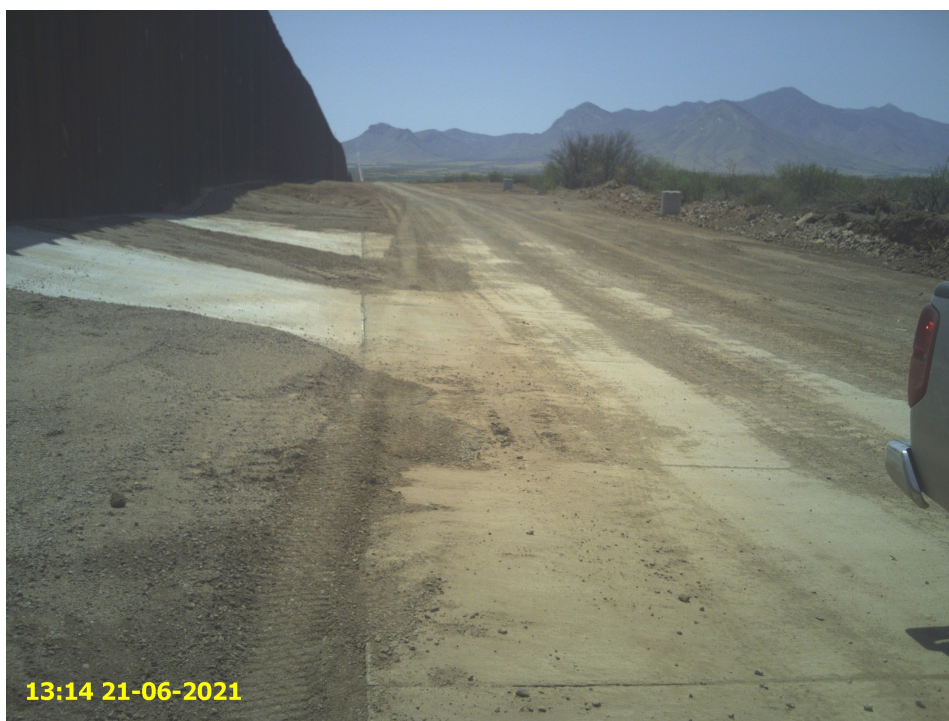
Disturbed areas outside the Roosevelt Reservation will be reseeded in accordance with specifications provided by Federal land managers

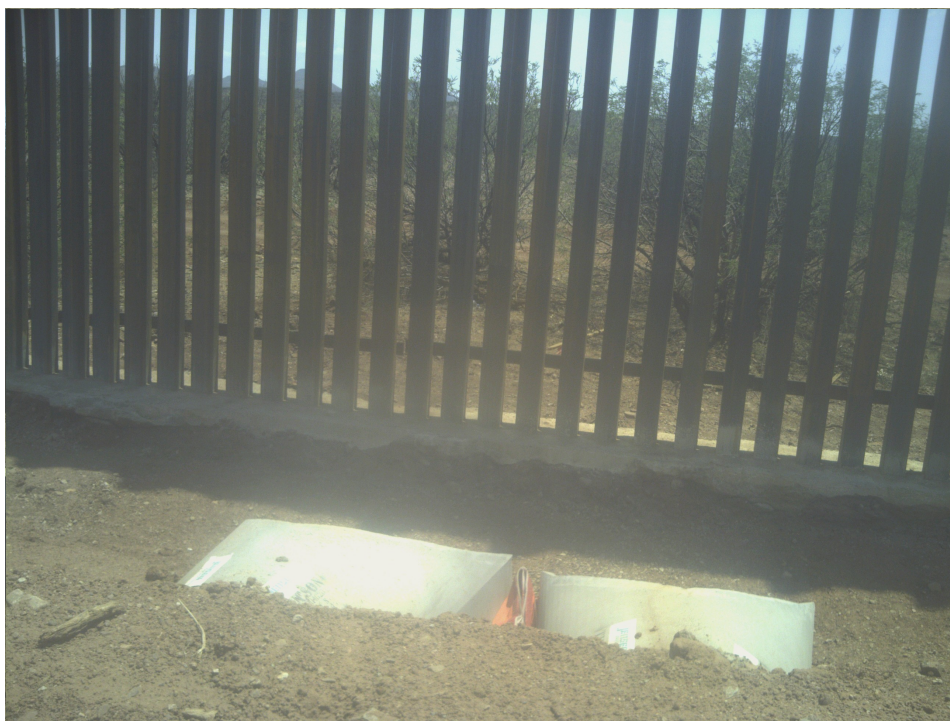
Protect culverts with appropriate drainage measures

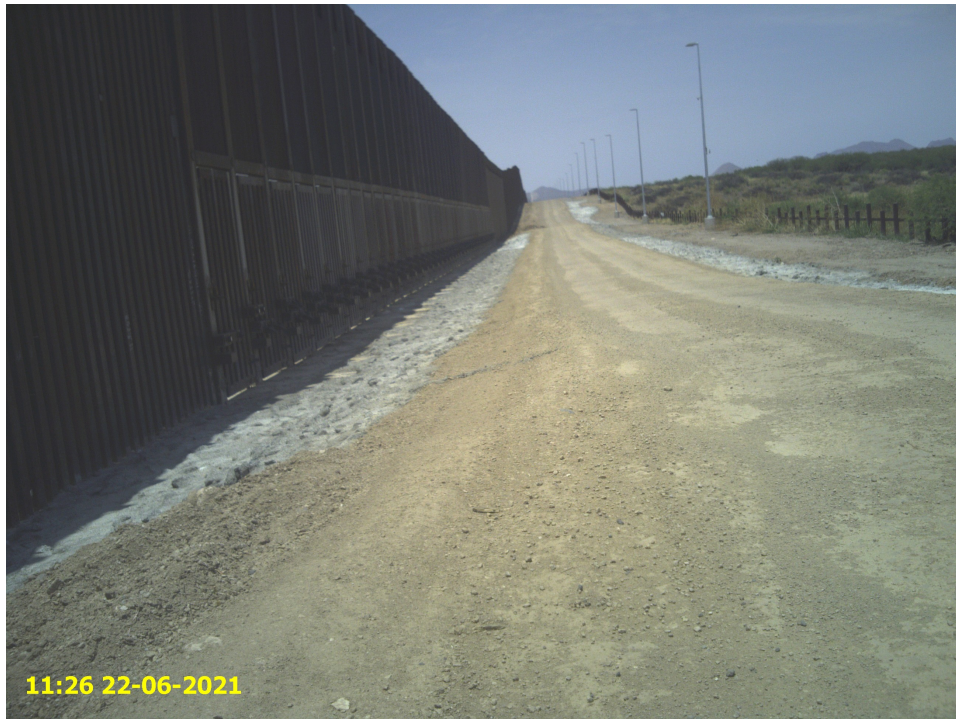
Protect low water crossings with appropriate drainage measures
